AN OVERVIEW OF THE CRASH DYNAMICS FAILURE BEHAVIOR
OF METAL AND COMPOSITE AIRCRAFT STRUCTURES

Huey D. Carden
NASA Langley Research Center
Hampton, VA

SUMMARY

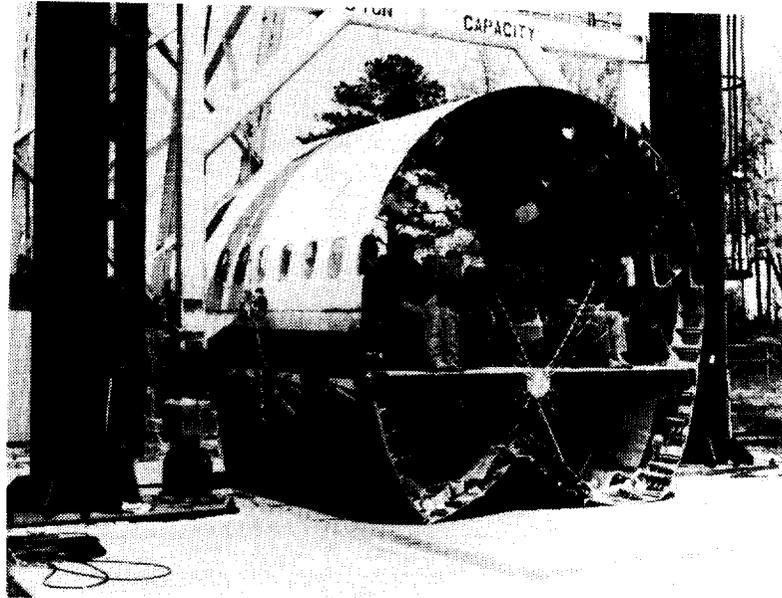
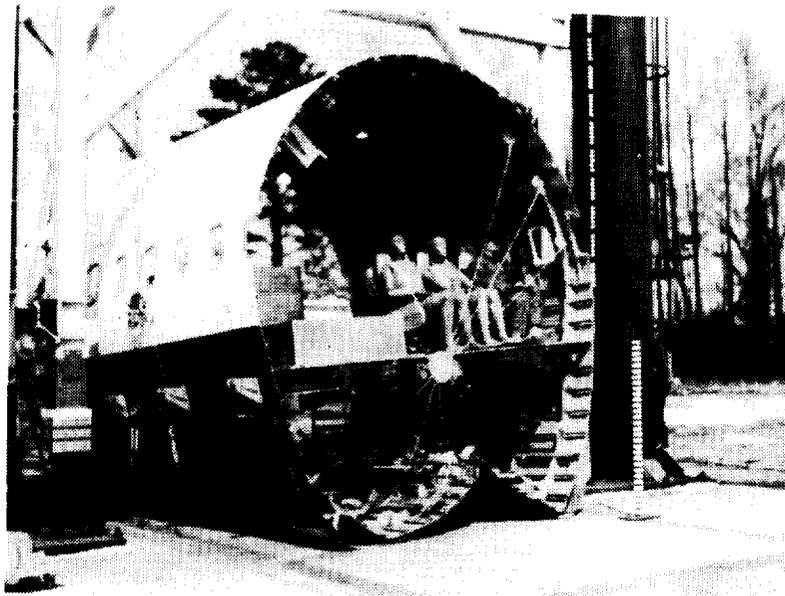
Figure 9.- Structural damage to metal aircraft structures.

Dynamic tests.- Structural damage and behavior of the transport aircraft structures resulting from the 20 ft/s drop tests is shown in figure 9(a) and (b). The damage to the transport sections was confined to the lower fuselage below the floor level. Under the vertical impact of 20 ft/s, all seven of the frames ruptured near the bottom impact point. Plastic hinges formed in each frame along both sides of the fuselage at about 50° up the circumference from the bottom contact point (See figure 9(c)). The upward movement of the lower fuselage was approximately 22-23 inches at the forward end and 18-19 inches at the rear for the section taken from forward of the wing location (figure 9(a)) whereas in the section from aft of the wing location (figure 9(b)), the crushing was about 14 inches forward and 18 inches in the rear. Although the aircraft structures are metal and the failures discussed above involve plastic deformations with some tearing of the metal rather than brittle fractures, the general observed failure pattern and locations for the transport fuselage sections will be shown to be quite similar to the results of the composite frames and subfloors discussed later.

(a) Section from forward of wing.

(b) Section from aft of wing.

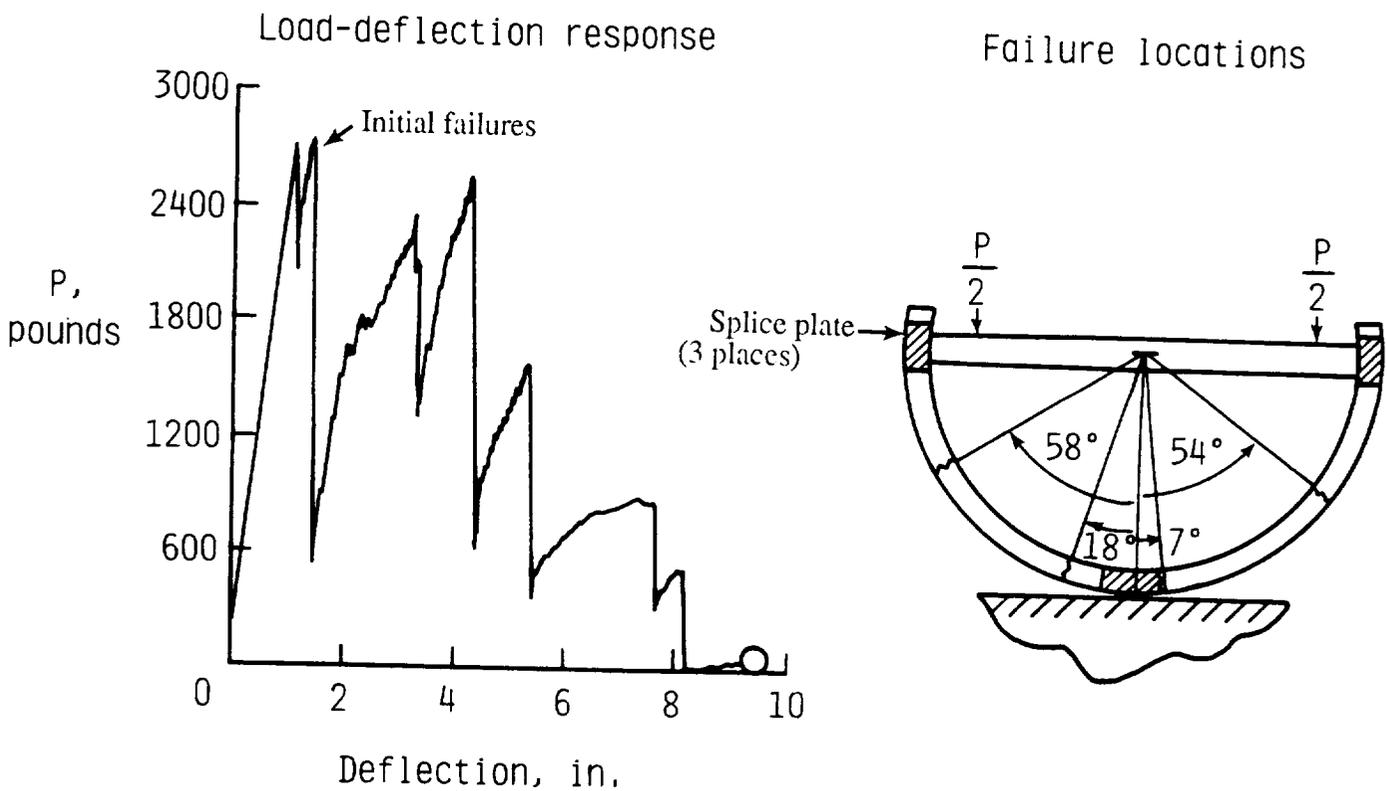
(b) Load-displacement and failure locations.

Static tests.- Figure 13 presents static results from tests of single composite Z-frames discussed in reference 26. A photograph of the static test apparatus in figure 13(a) shows that the splice plate was at the load point. The frame failed just outside the doubler splice plate area by a complete fracture across the Z-section. Load-deflection data and the location of failures of the frame are shown in figure 13(b). The load-deflection data show a saw-toothed behavior beginning with the essentially linear behavior of the frame up to initial failure with subsequent loading of the frame after failure being at a new, reduced stiffness for the damaged frame. Photographic data in figure 13(c) show that the initial failure was induced by a local buckling of the frame which occurred at about 18° from the bottom loading point outside the splice plate area. Second and third fractures occurred up the side at about 54° and 58° under continued loading as may be noted in the sketch at the right of figure 13(b). The sequence of events was local buckling near the splice plate induced out of plane deformations which led to a fracture of the section; the ends then remained in contact (jammed together under the compressive loads in the frame), the initial point of fracture moved vertically, essentially in a guided manner until two additional fractures occurred farther up the frame.

A comparison of the analytical cases (figure 14(a)) with the actual static load-deflection of the Z-section (figure 13(b)) indicates very similar load-deflection behavior patterns as discussed above. Although the Z-frame had no skin, if the ends jam together (as they did in several cases), the boundary is effectively between the skin stiffened case and a guided boundary. Thus, the predicted failure location in the simple beam-frame model at about 50° (See figure 14(b)) agrees well with the 54° and 58° failure locations in the experiment with the Z-section frame.

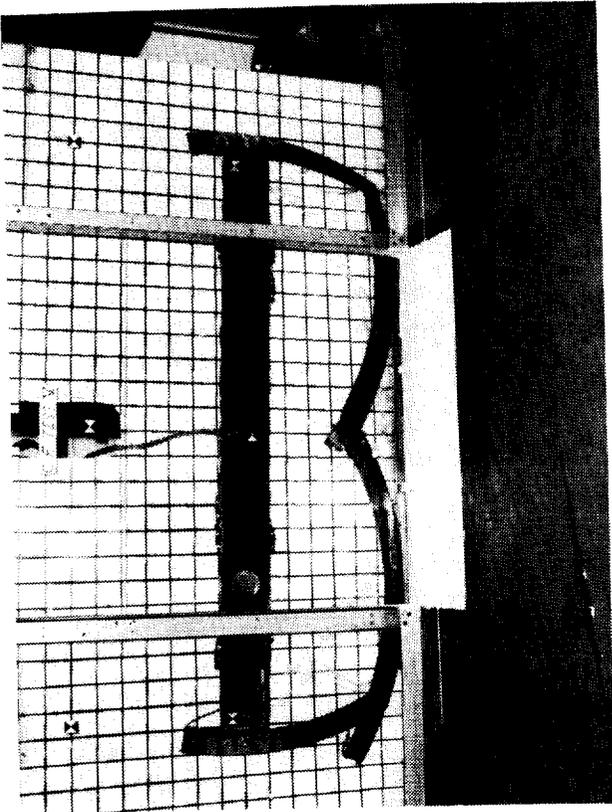
(a) Photographs of failed frames.

Dynamic tests.- Figure 15 presents results from the dynamic studies of the response of composite frames (Reference 27). As noted in figure 15(a) or (b), the splice plates joining the segments of the frame are $\pm 45^\circ$ up the circumference from the point of impact. As shown in figure 15(b) complete failures (fractures) of the Z-section frames occurred at the bottom and approximately $\pm 60^\circ$ from the bottom. Potentially, it appears that the presence of the splice plates may have influenced the locations by moving the top failure points up a few degrees to about the $\pm 60^\circ$ locations.

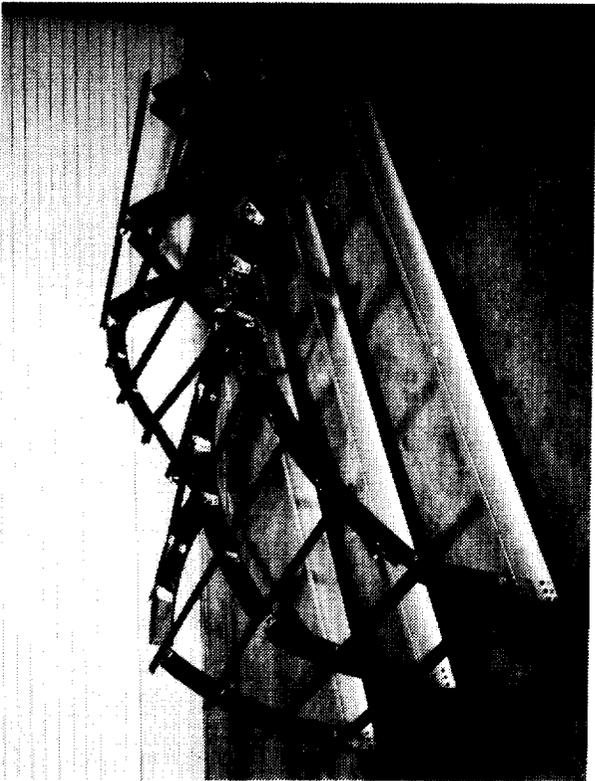
(a) Failed skeleton subfloor.

Static tests.- Figure 16 presents experimental results (Reference 28) of the skeleton subfloor specimen following a static test. As noted in figure 16(a) and (b), failures on the three Z-section frames occurred at 13 discrete locations. Unlike the unnotched single Z-frame, the failures in this specimen occurred at notches (which served as stress risers) in the frame through which the stringer passed. However, as shown in figure 16(b) the failures were still near the point of load application (approximately 11°) and at other circumferential

locations of approximately 45-68°. In the absence of skin material, twisting and bending out-of-plane occurred with the frames. The stringers had minimal effect on the subfloor response with the exception of maintaining the lateral spacing of the three Z-frames.

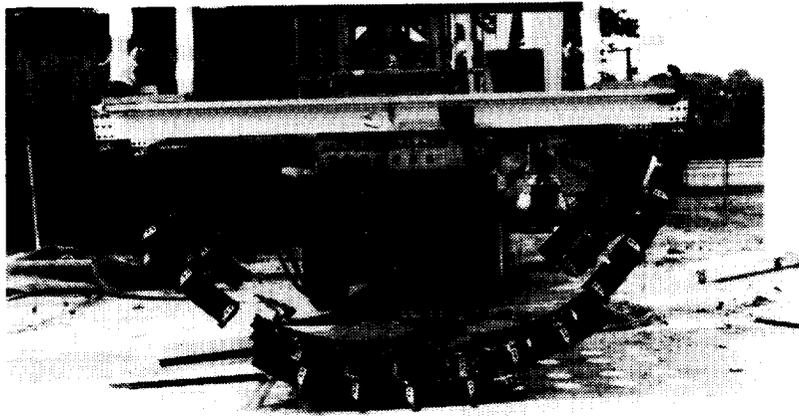
(a) Failed skeleton subfloor.

Dynamic tests.- Figure 17 shows the skeleton subfloor after an impact test onto a concrete surface at 20 feet per second. In the dynamic test of the skeleton subfloor, fractures were produced at notches in the frames (Figure 17(a)). The locations, shown in figure 17(b), were also near the point of impact (about 11° because of the splice plate) and at two other locations up the circumference of the frames ($\pm 45^\circ$ and $\pm 78^\circ$) and involve all three frames for a total of 15 fractures. The impact energy exceeded the energy absorbed by the local fractures and the floor bottomed out in the impact. Figure 17(c) is a normalized strain distribution measured on the first (end) frame during the dynamic test just before first failure. A comparison of the distribution to the moment distribution of Figure 14(b) and (c) shows essentially identical shape between the single frame and skeleton frame distributions. Maximums at 0° and at approximately $\pm 50^\circ$ to 55° agree well with the analytically predicted locations on the frame.

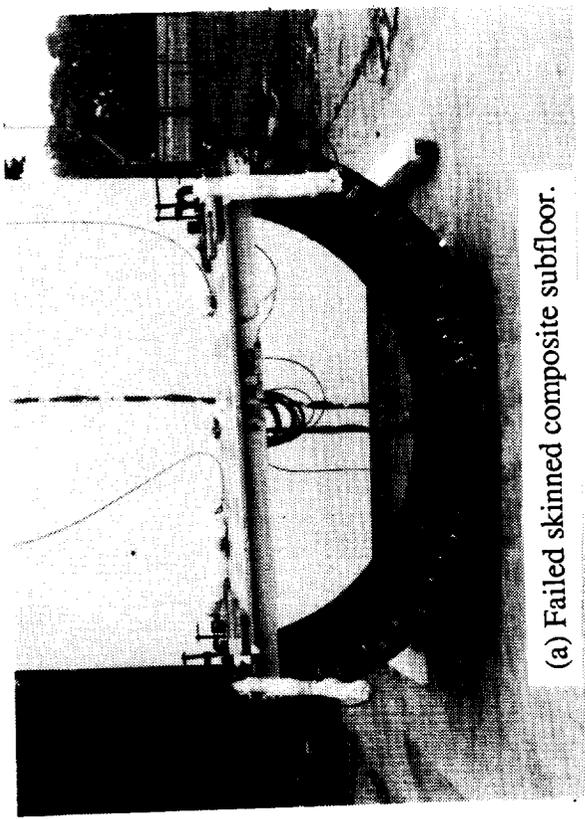
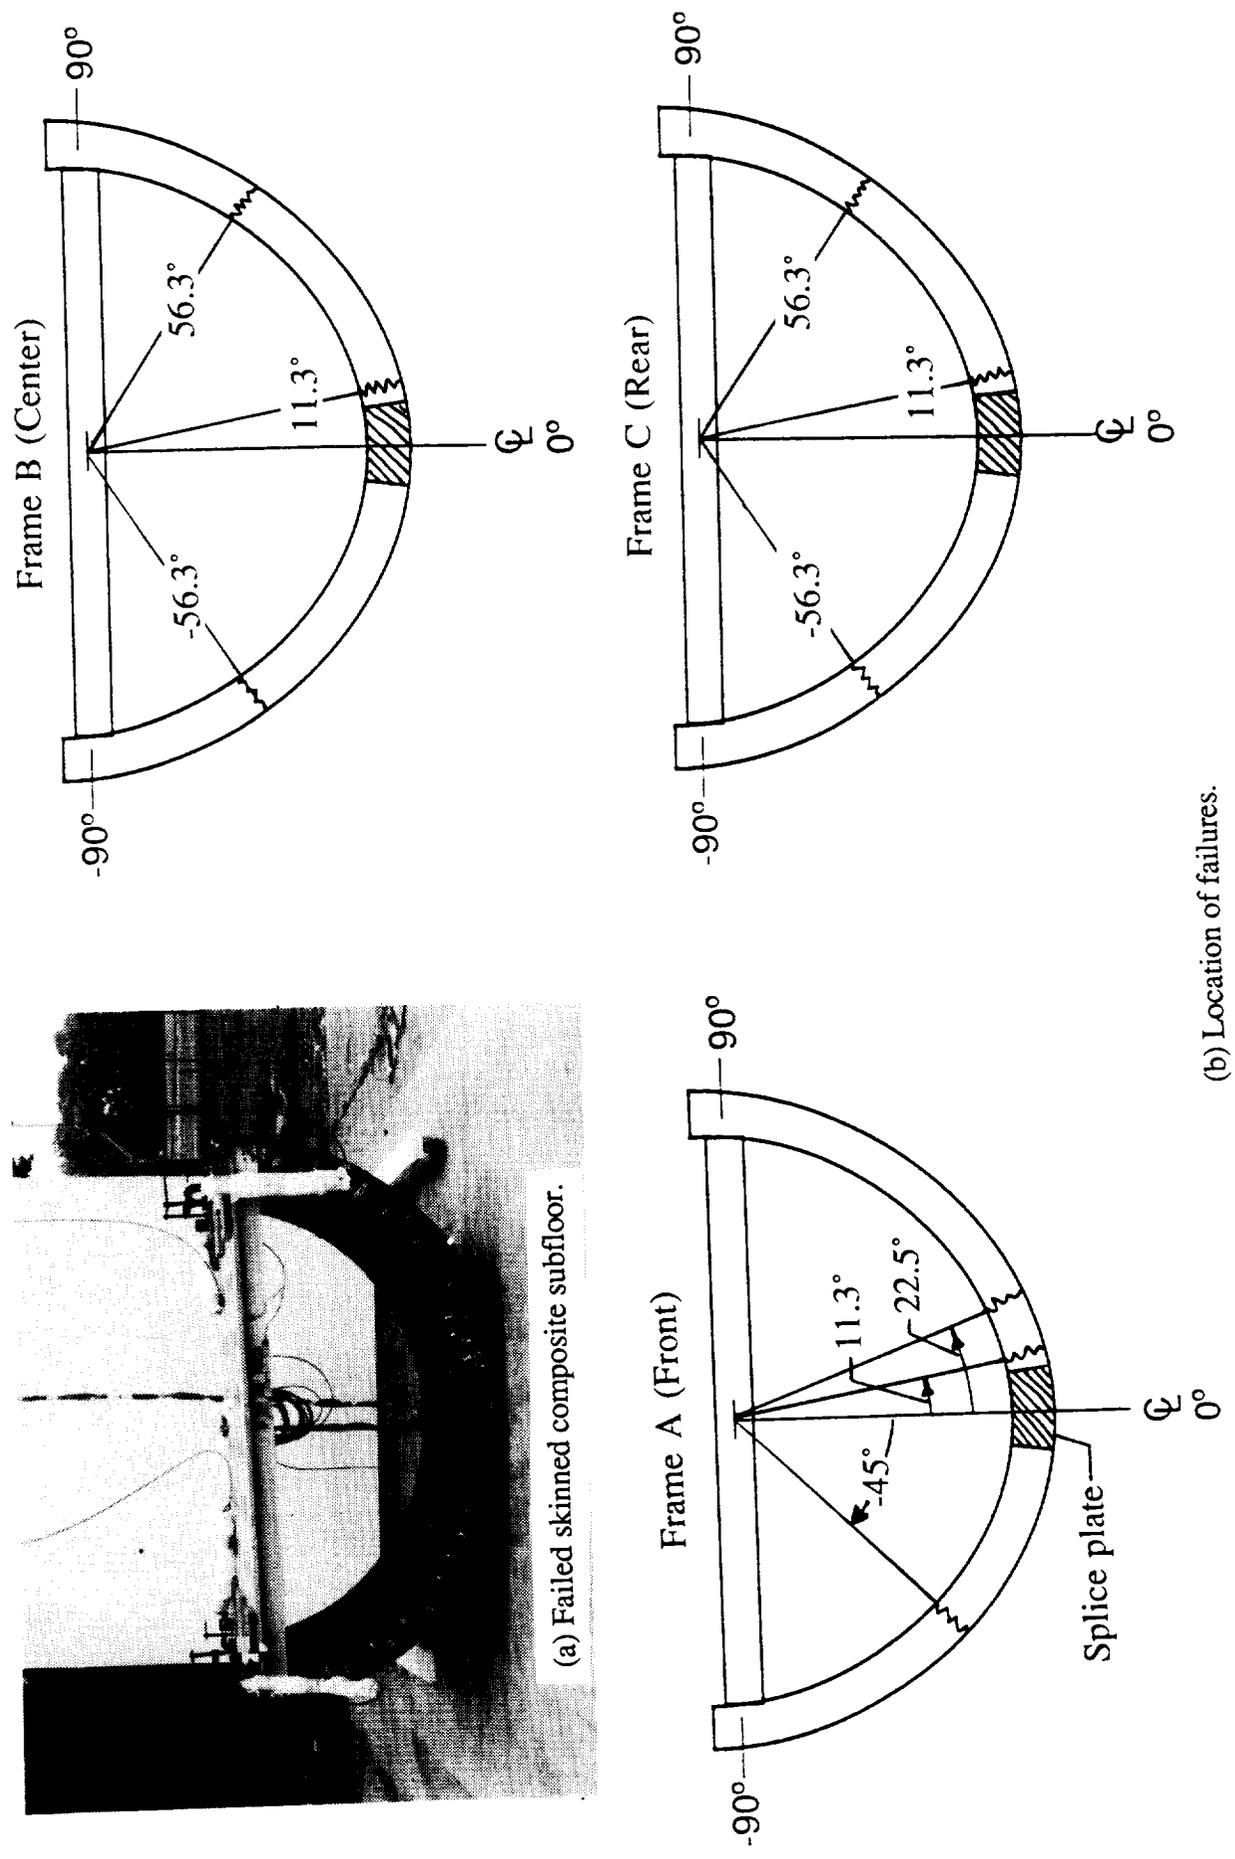
Figure 18.- Behavior of skinned composite subfloor under dynamic loading tests.

Figure 18 presents impact results for the subfloor with skin after an impact of 20 feet per second. Figure 18(a) is the subfloor specimen after the test. Points of failure of the frames in this specimen are indicated in figure 18(b). Again the points of failure are at/near the impact point (within 12°) and on the circumference at about $\pm 56^\circ$ up both sides of the frame on the middle and back frame and 11°, 22.5° and 45° on the front frame. It was observed that the subfloor impacted first on the front area which possibly explains the 11° and 22.5° fractures being different from the other locations. Again all three frames were involved in the failures. Some delamination of the frames from the skin was evident but the skin remained intact. Figure 18(c) is a normalized strain distribution (just prior to first failure) measured on the first (end) frame during the dynamic test. A comparison of the distribution to the moment distribution of Figure 14(b) and (c) and the strain distribution in Figure 18(c) shows essentially identical shape as the single frame and skeleton frame distributions. As was the case for the skeleton subfloor maximums at 0° and at approximately $\pm 50^\circ$ to 55° agree well with the analytically predicted locations on the frame.
